# Tech Info Library

## Macintosh: Using High-Density Disks in 800K Drives (01/95)

Article Created: 12 August 1993  
Article Reviewed/Updated: 13 January 1995

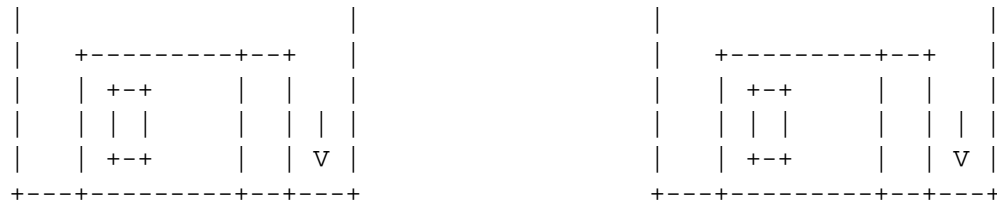
When you move this disk to a Macintosh with a SuperDrive, the newer drive recognizes the disk as a high-density floppy by its extra hole. Since the disk has been formatted as 800K instead of as 1.4MB, the SuperDrive misreads it and asks you if you want to initialize it.

+---+-----+---+	+---+-----+---+
@	High ---->  @     @
	Density
+-----+	Hole   +-----+

As a temporary workaround, place a small piece of tape over both sides of the extra hole (the one on the upper left when looking at the diskette from the front, as shown in the above diagram) on the high-density disk to trick the Macintosh into treating the disk as a double-density disk. This is a temporary solution, and the tape should be removed and the disk reformatted to the proper size as soon as possible.
